INSPECTION REPORT
2198 The actual Report Dr
East Point GA 30344

INSPECTED BY
Christopher Boykin
Foresight Home
Inspections, LLC

INSPECTION DATE
📅 6/23/2024
🕒 09:00 AM

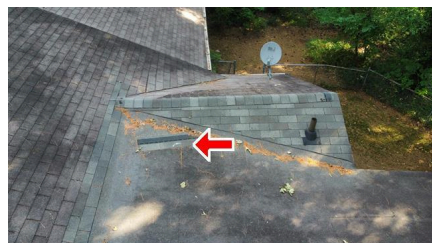
1.0 Item 1 (Picture)

There were areas that have been patched on the roof system. A few shingles are loose or missing. I recommend a licensed roofer evaluate further and repair any defects observed.

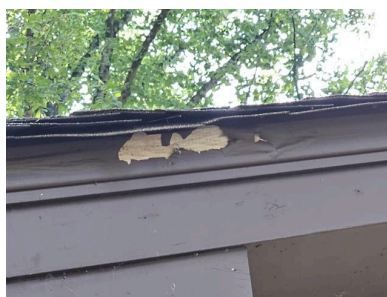
2.0 Item 5 (Picture)

The Wood trim in areas is peeling paint or failing. Further deterioration can occur if not corrected. I recommend prep and paint using a qualified contractor.

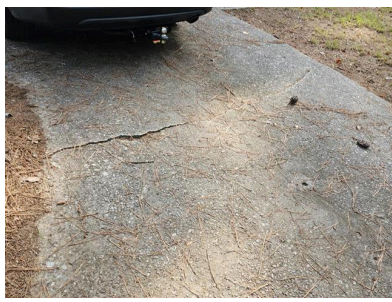
**2.4 Item 1 (Picture)**

The concrete drive and concrete walkway at the are uneven, and can be a tripping hazard. Further deterioration can occur if not repaired. A qualified contractor should evaluate and repair as needed.

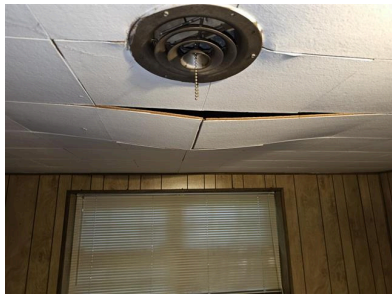
4.0 Item 1 (Picture)

(1) The Ceiling Tile on the ceiling are warped or buckled in basement room and needs repair. While this damage is cosmetic, it needs to be repaired.

A qualified contractor should evaluate and repair as needed.

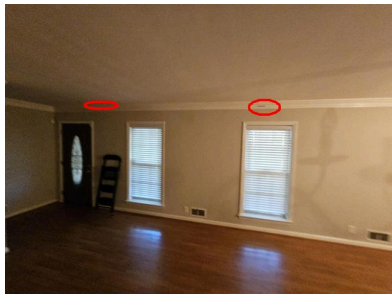
4.0 Item 3 (Picture)

(2) The ceiling trim/moulding is damaged at some areas of the Living Room. I recommend a qualified contractor correct as desired.

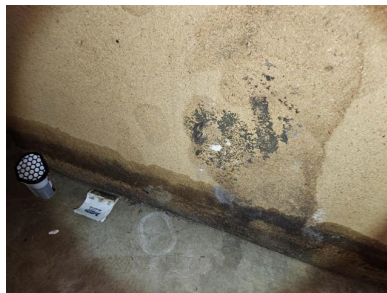
4.1 Item 2 (Picture)

Signs of fungi growth is present on the walls along basement in several areas. We did not evaluate, test or determine if this growth is or is not a health hazard. The underlying cause is moisture.

No moisture detected with moisture meter at time of inspection.

I recommend you contact a mold inspector or expert for investigation or correction if needed.

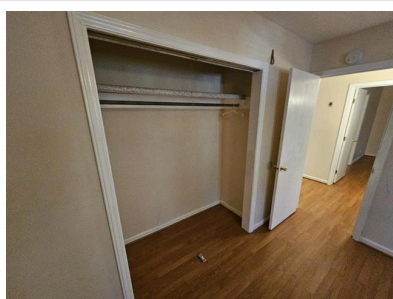
4.5 Item 1 (Picture)

(1) The Closet door is missing at the Bedroom. . A qualified person should replace as needed.

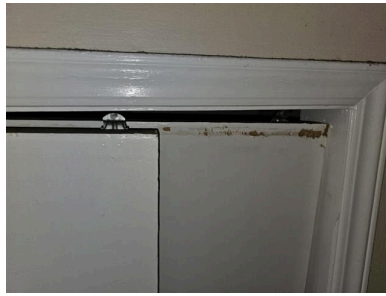
4.5 Item 3 (Picture)

(2) The Closet door needs adjustment at the Bedroom. A qualified contractor should evaluate and repair as needed.

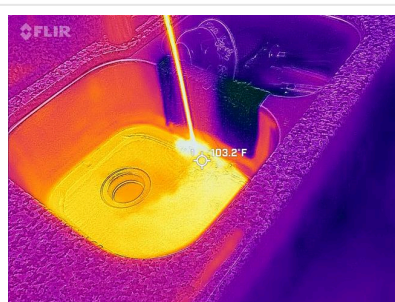
Infrared camera view of hot water

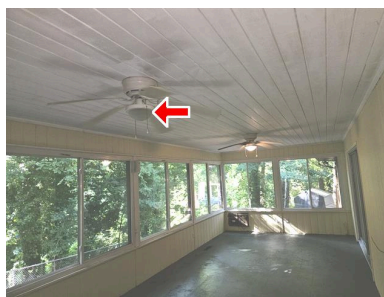
7.3 Item 9 (Picture)

(7) This light fixture leading to the basement did not operate at time of inspection. Likely the bulb. I recommend a contractor evaluate further and repair as needed.

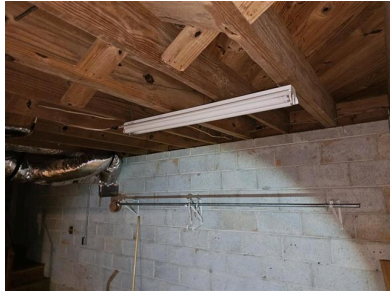
7.3 Item 12 (Picture)

(10) This light fixture cover was loose in the basement. I recommend a qualified contractor evaluate further and repair as needed.

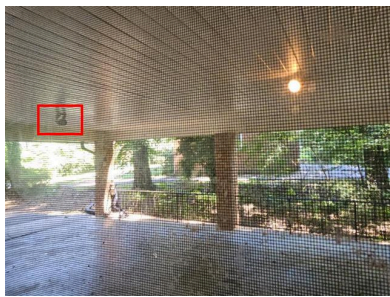
7.3 Item 14 (Picture)

(12) This light fixture did not operate, but the fan did. I recommend a qualified contractor evaluate further and repair as needed. Likely the bulb.

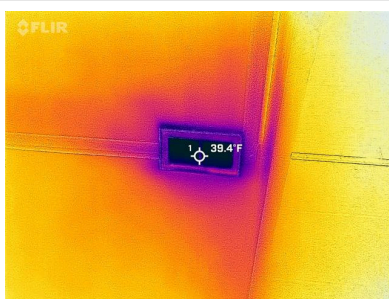
Infrared camera view of heating

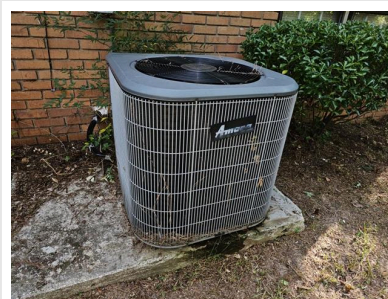
Infrared camera view of cooling

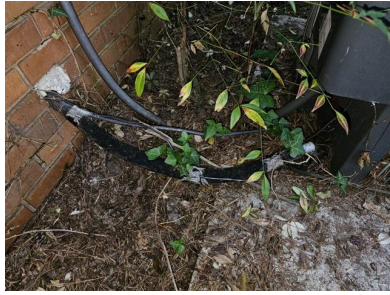
8.6 Item 2 (Picture)

(2) The foam sleeve on suction line is missing foam sleeve or decaying in area(s) at outside unit. Missing foam on suction line can cause energy loss and condensation.

I recommend a contractor or HVAC technician evaluate system further and repair as needed.

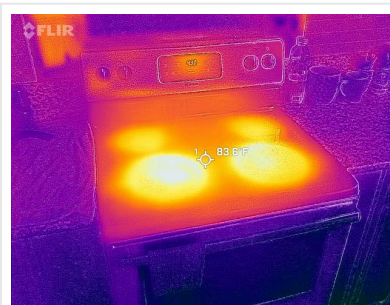
Infrared camera view of cooktop

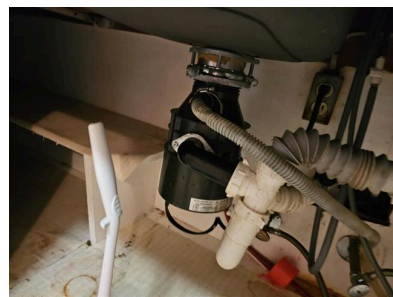
10.3 Item 1 (Picture)

The food disposer would not operate or non functional. I recommend repair as needed.

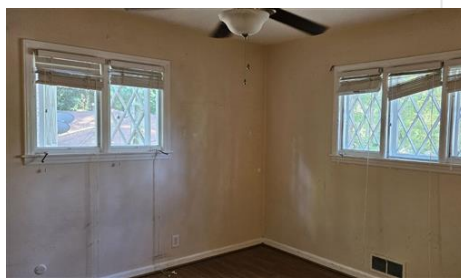
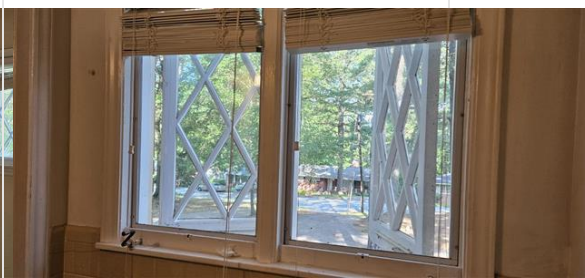
2.2 Item 1 (Picture)

Some of the casement windows have small cracks. Cosmetic. I recommend a contractor repair as needed.

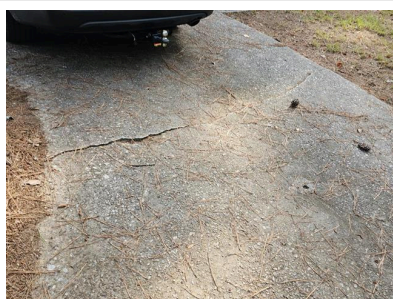
2.4 Item 1 (Picture)

The concrete drive and concrete walkway at the are uneven, and can be a tripping hazard. Further deterioration can occur if not repaired. A qualified contractor should evaluate and repair as needed.

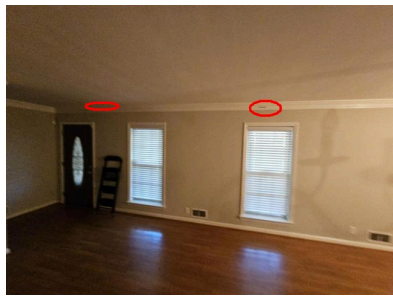
4.0 Item 3 (Picture)

(2) The ceiling trim/moulding is damaged at some areas of the Living Room. I recommend a qualified

contractor correct as desired.

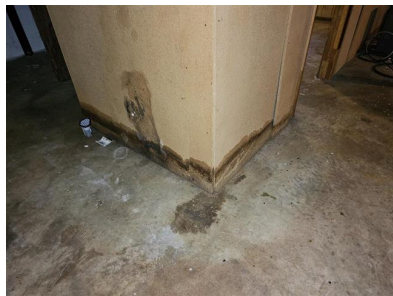
4.1 Item 1 (Picture)

No moisture detected with moisture meter at time of inspection.

I recommend you contact a mold inspector or expert for investigation or correction if needed.

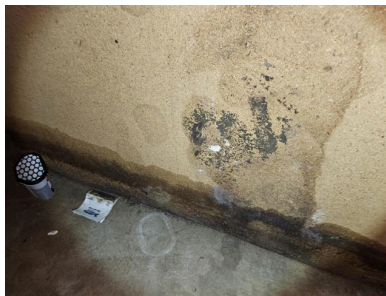
4.1 Item 2 (Picture)

Signs of fungi growth is present on the walls along basement in several areas. We did not evaluate, test or determine if this growth is or is not a health hazard. The underlying cause is moisture.

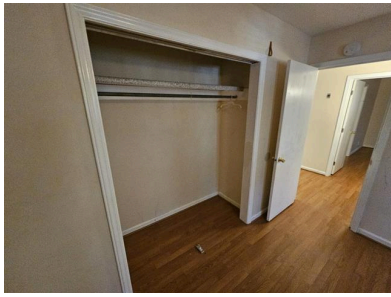
4.5 Item 1 (Picture)

(1) The Closet door is missing at the Bedroom. . A qualified person should replace as needed.

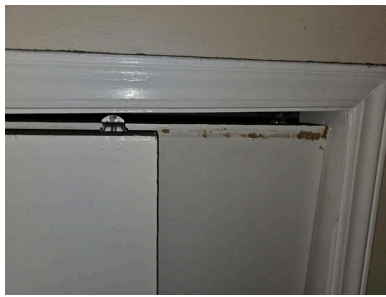
4.5 Item 3 (Picture)

(2) The Closet door needs adjustment at the Bedroom. A qualified contractor should evaluate and repair as needed.

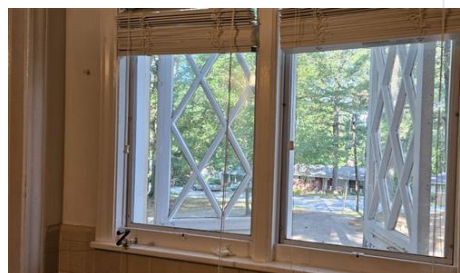
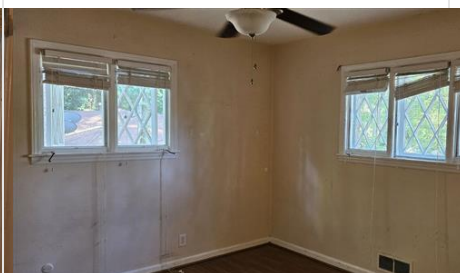
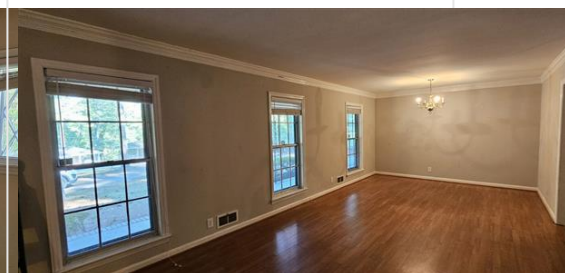
(1) The windows in these bedrooms and jack and jill bathroom are inoperable glass panes.

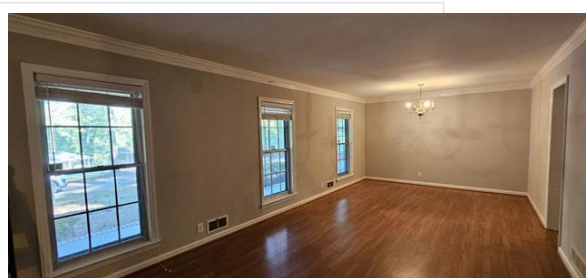
4.6 Item 4 (Picture)

(2) Living room windows did not operate at time of inspection. I recommend a contractor repair as needed.

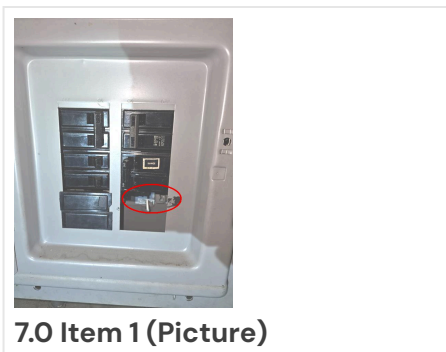
Knockouts missing. I recommend a license electrician or contractor evaluate and make necessary repair.

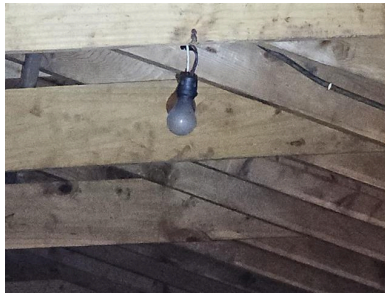
7.3 Item 5 (Picture)

(4) This outlet in the bathroom did not trip when tested. I recommend a licensed electrician or contractor evaluate further and repair as needed.

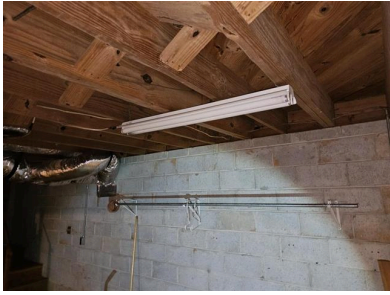
7.3 Item 12 (Picture)

(9) This light fixture did not operate in the basement. I recommend a qualified contractor evaluate further and repair as needed. Likely the bulb.

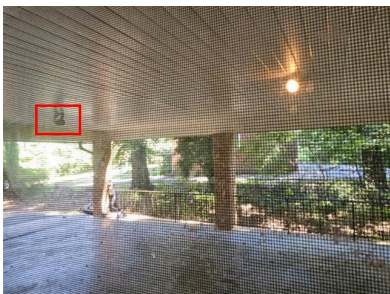
7.3 Item 14 (Picture)

(11) This light fixture did not operate. I recommend a qualified contractor evaluate further and repair as needed. Likely the bulb.

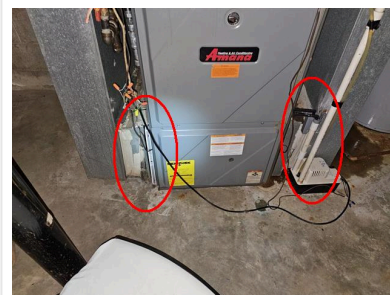
8.2 Item 3 (Picture)

The plenum shows are where the system is loose at the main plenum or ducttape is loose. Energy loss is occurring where duct tape has failed. Also cover to filter area is open.

I recommend a licensed HVAC technician evaluate system further and repair as needed.

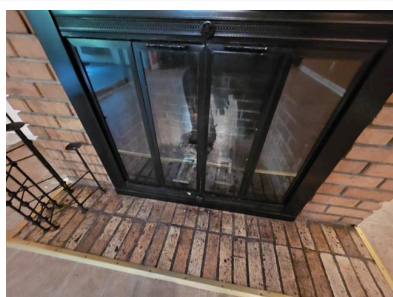
8.4 Item 1 (Picture)

The door to the fireplace was seized. No access. I recommend a qualified contract evaluated further and repair if needed.

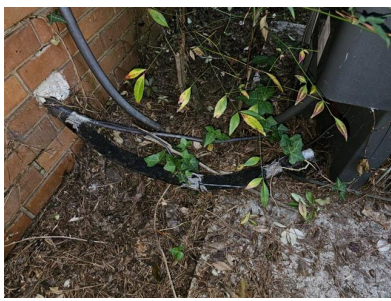
8.6 Item 2 (Picture)

(2) The foam sleeve on suction line is missing foam sleeve or decaying in area(s) at outside unit. Missing foam on suction line can cause energy loss and condensation.

I recommend a contractor or HVAC technician evaluate system further and repair as needed.

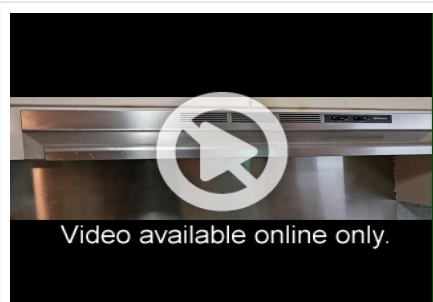
10.2 Item 1 (Video)

The range hood fan noisy or vibrates. I recommend repair or replace as needed.
